Your Inspection Report

123 Main Street
Coquitlam, BC V1V 1A1

INSPECTION DATE:
Monday, May 30, 2011

RE: Report No. 1010, v.0
123 Main Street
Coquitlam, BC
V1V 1A1

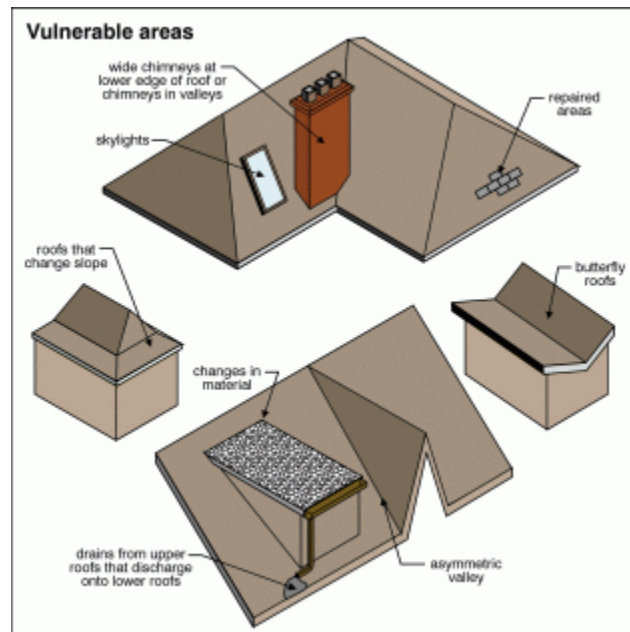
Condition: • [Vulnerable areas](#)

Implication(s): Chance of water damage to contents, finishes and/or structure

Task: Clean

Time: Less than 1 year

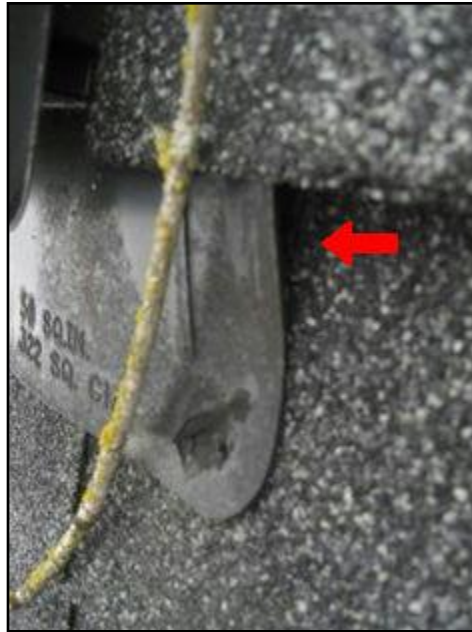
Condition: • The sides of the attic vents are lifting near the bottom of the vents. This can allow rain to enter under the vents and ultimately into the house.

Implication(s): Water Entry, water Damage.

Task: Repair or replace

Time: Less than 1 year

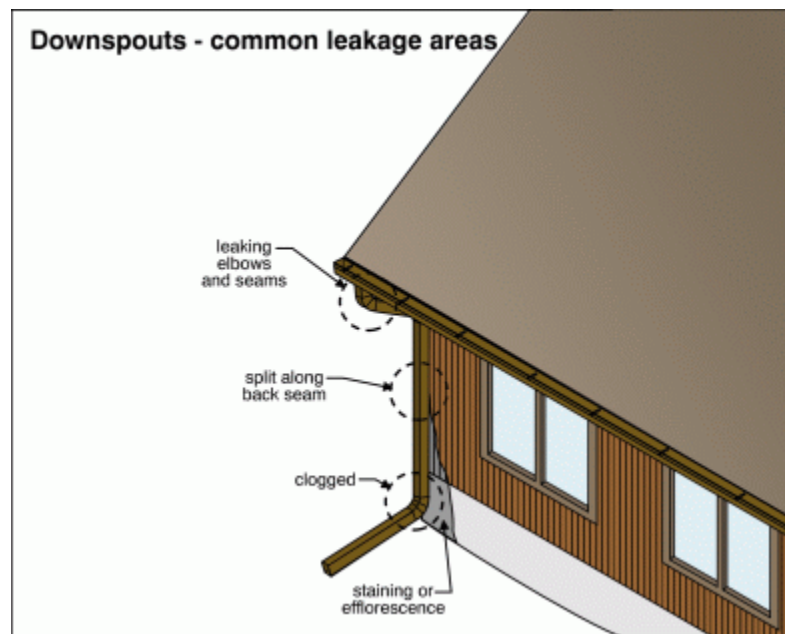
Condition: • [Damage](#)

Almost all down spouts have some form of mechanical damage. It is recommended to monitor this damage and replace the downspout's if they start to leak.

Implication(s): Chance of water damage to contents, finishes and/or structure

Task: Monitor

Time: Ongoing

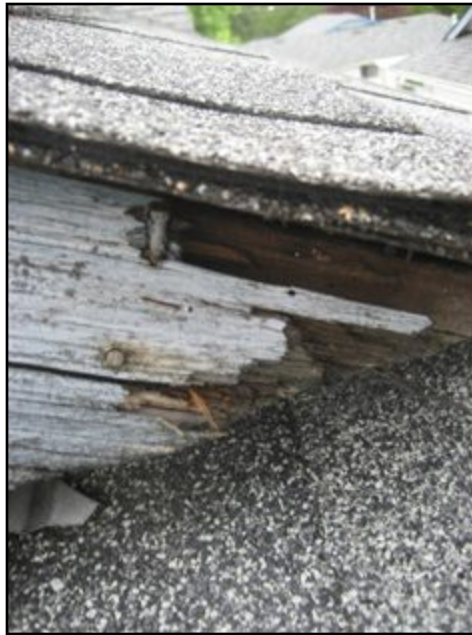
Rotted Fascia

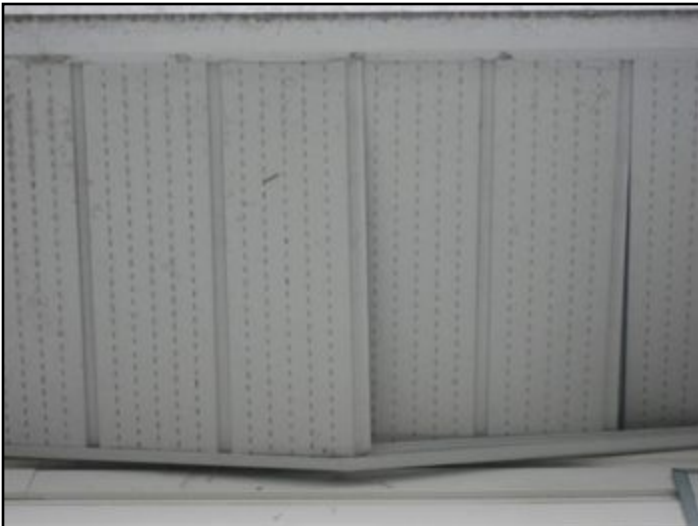
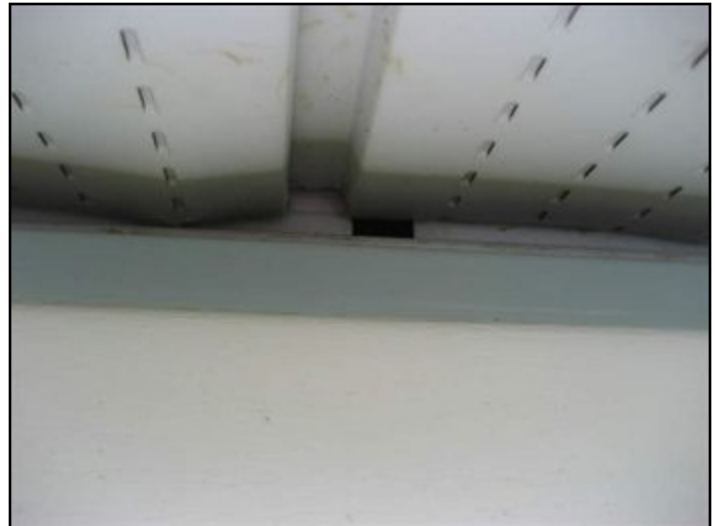
Condition: • [Loose or missing pieces](#)

The soffit is loose in many areas.

Implication(s): Cosmetic defects | Chance of water damage to contents, finishes and/or structure | Chance of pests entering house

Task: Repair or replace

Time: Less than 1 year

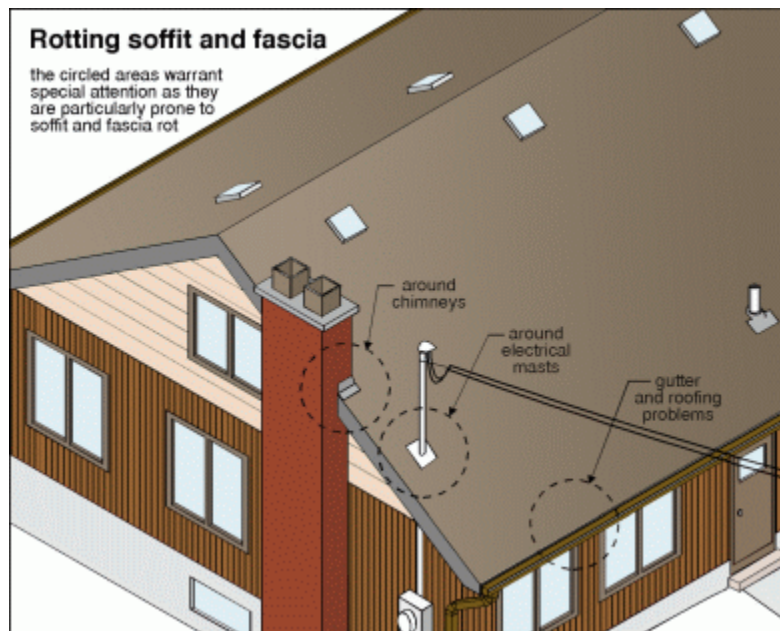
Condition: • [Damage](#)

The soffit on the south side is damaged.

Implication(s): Cosmetic defects | Chance of water damage to contents, finishes and/or structure

Task: Repair or replace

Time: Immediate

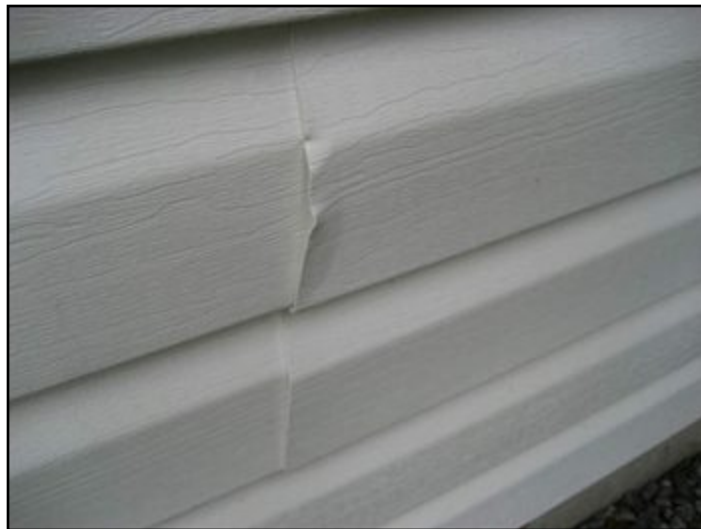
Condition: • [Mechanical damage](#)

Some minor damage was noted to the siding in various places.

Implication(s): Cosmetic defects | Chance of water damage to contents, finishes and/or structure

Task: Correct

Time: Discretionary

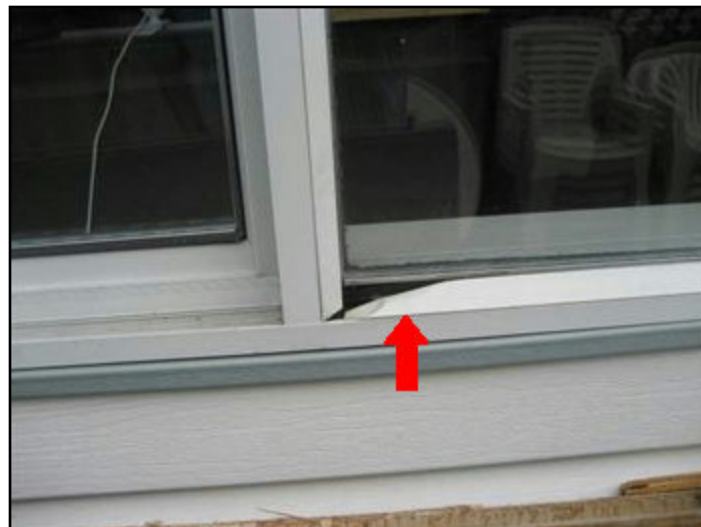
EXTERIOR GLASS \ Sashes

Condition: • [Sash coming apart](#)

Sashes on several basement windows have mechanical damage

Task: Repair or replace

Time: Less than 2 years

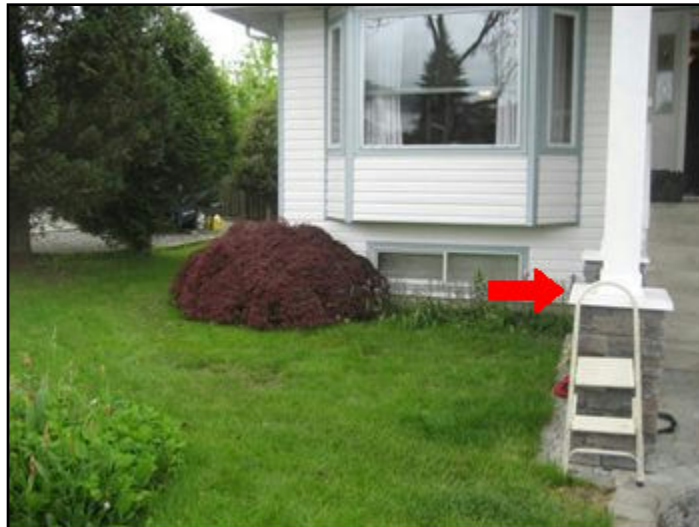
Condition: • The Columns on the front porch are loose. It was not however determined if the pillar is loose or if it is simply the decorative outer part that is loose. It is recommended to have a structural professional determine if the pillars are sound.

Implication(s): Collapse, Structural damage.

Task: Further evaluation by Professional

Time: Less than 1 year

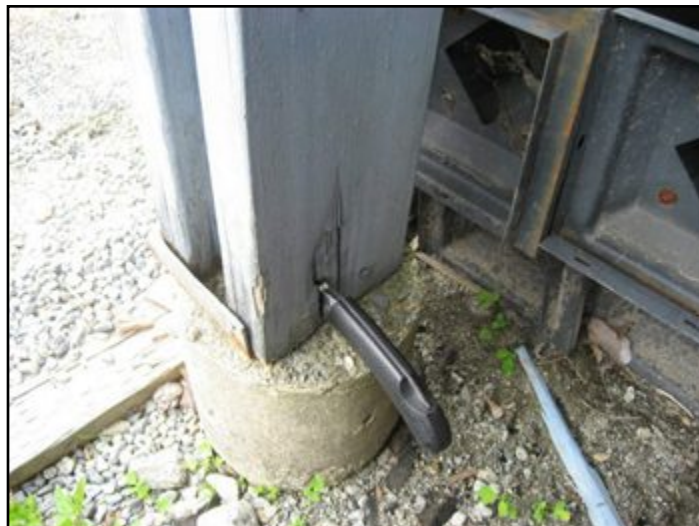
Condition: • [Rot or insect damage](#)

The pillar on the north side of the deck is rotted at the bottom

Rot on deck support.

Task: Repair or replace

Time: Immediate

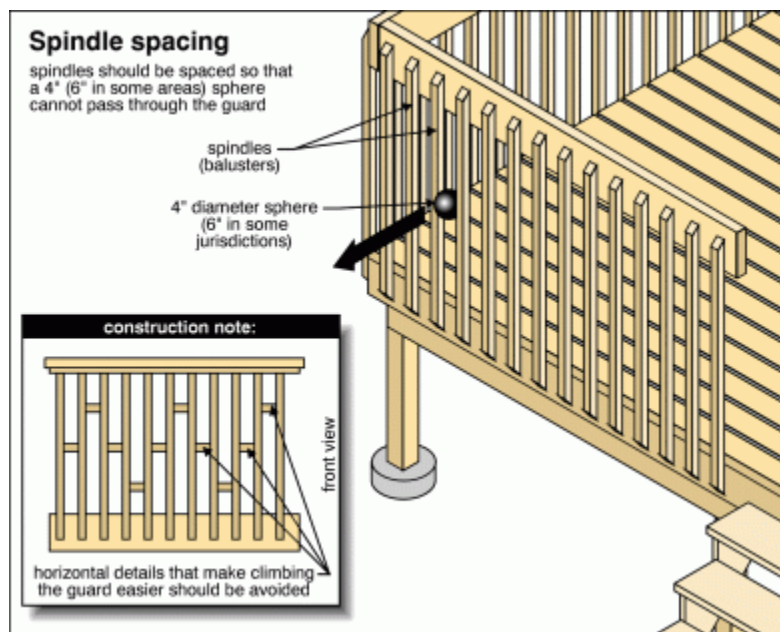
Condition: • [Spindles too far apart](#)

Stars from upper deck to lower deck have no spindles at all. This hand rail is also not very secure.

Implication(s): Fall hazard

Task: Improve

Time: Immediate

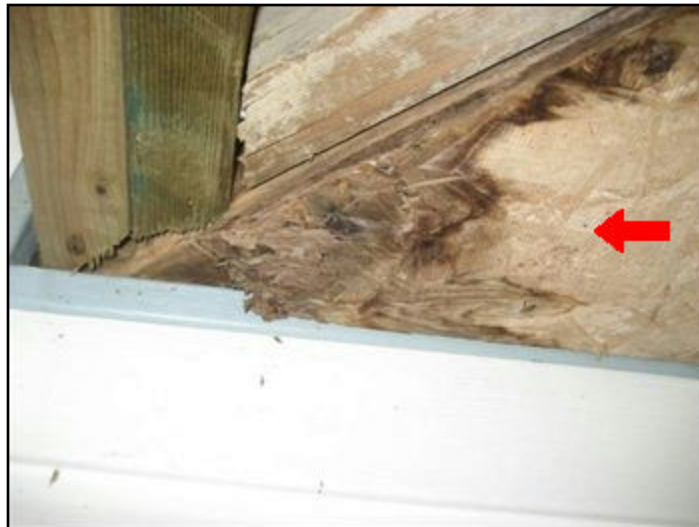
Condition: • [Rot](#)

OSB sheathing was used to enclose a small area on the underside of the deck. OSB should not be used where it comes in contact with water. The OSB is starting to rot.

Task: Repair or replace

Time: Less than 1 year

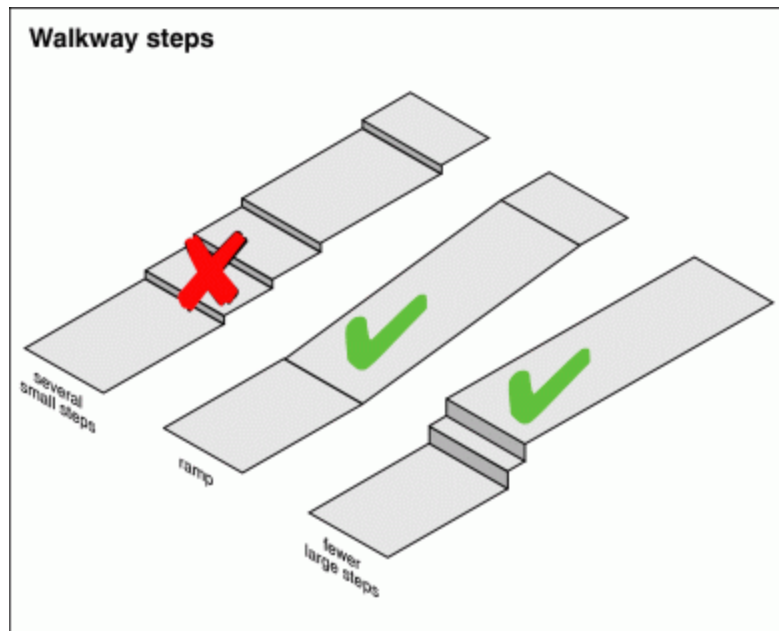
Condition: • [Uneven \(trip hazard\)](#)

Bricks on the transition from gravel to patio stone are loose.

Task: Improve

Time: Less than 1 year

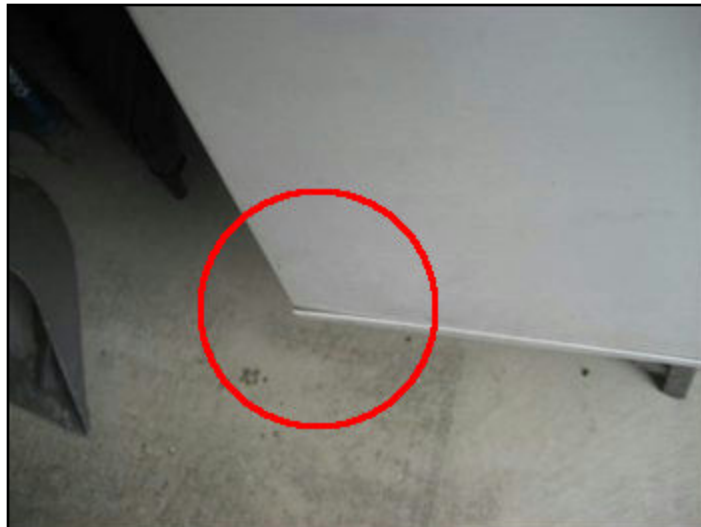
Condition: • [Weatherstripping missing or ineffective](#)

The sweeper on Exterior man door into garage does not fit tightly up against door. This can allow water to get in under the weather stripping and rot the wood of the door.

Task: Repair or replace

Time: Less than 1 year

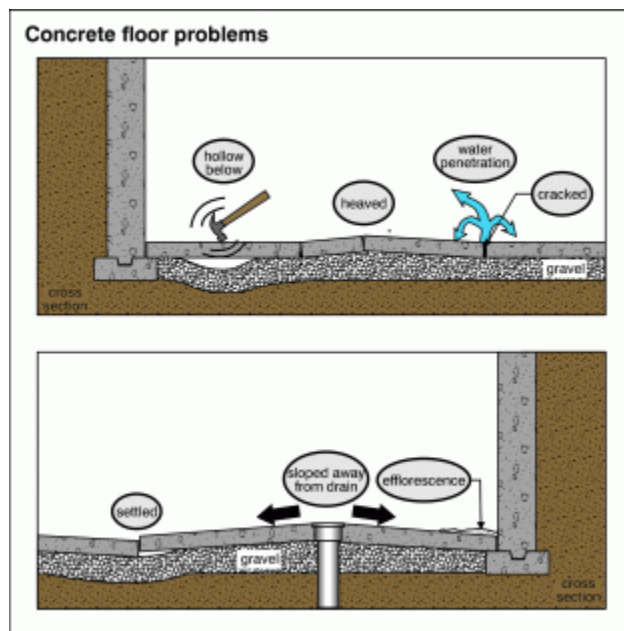
Condition: • [Cracked](#)

There is a large crack in the floor slab by the furnace. It is recommended to monitor this crack to make sure it does not become wider.

Implication(s): Cosmetic defects | Chance of water damage to contents, finishes and/or structure | Trip or fall hazard

Task: Monitor

Time: Ongoing

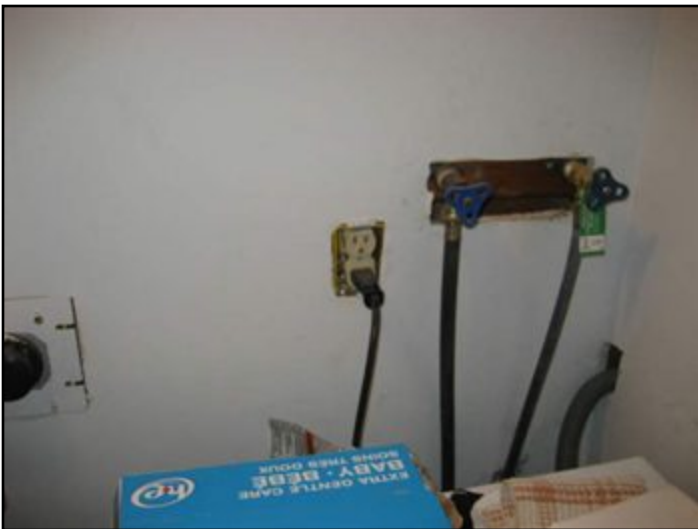
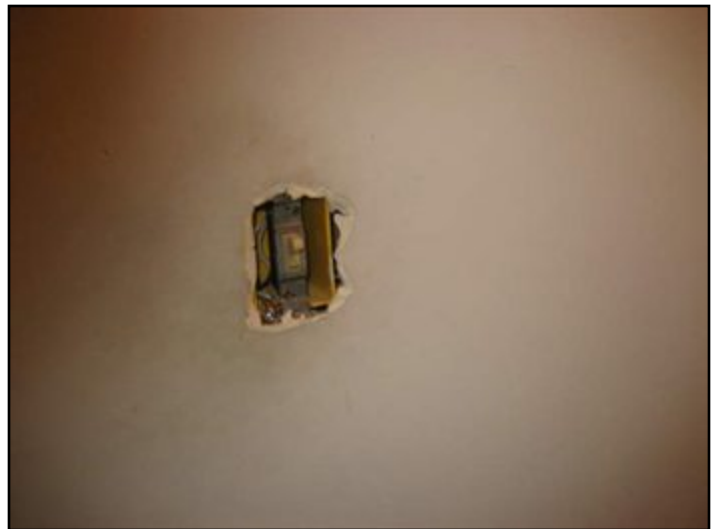
DISTRIBUTION SYSTEM \ Cover plates**Condition:** • [Missing](#)

Cover Plates are missing on several switches and receptacles. It is recommended that these be provided where they are missing.

Task: Provide

Time: Immediate

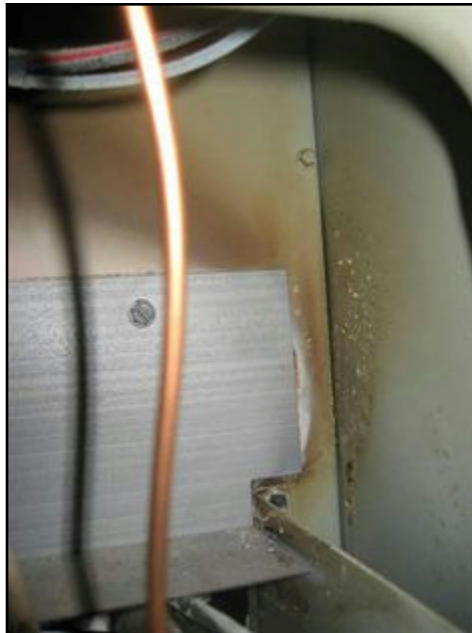
Condition: • [Scorching](#)

There are scorch marks around the heat shield. It is recommended to have it serviced if not replacing immediately.

Implication(s): Equipment not operating properly | Hazardous combustion products entering home | Fire hazard

Task: Service

Time: Immediate

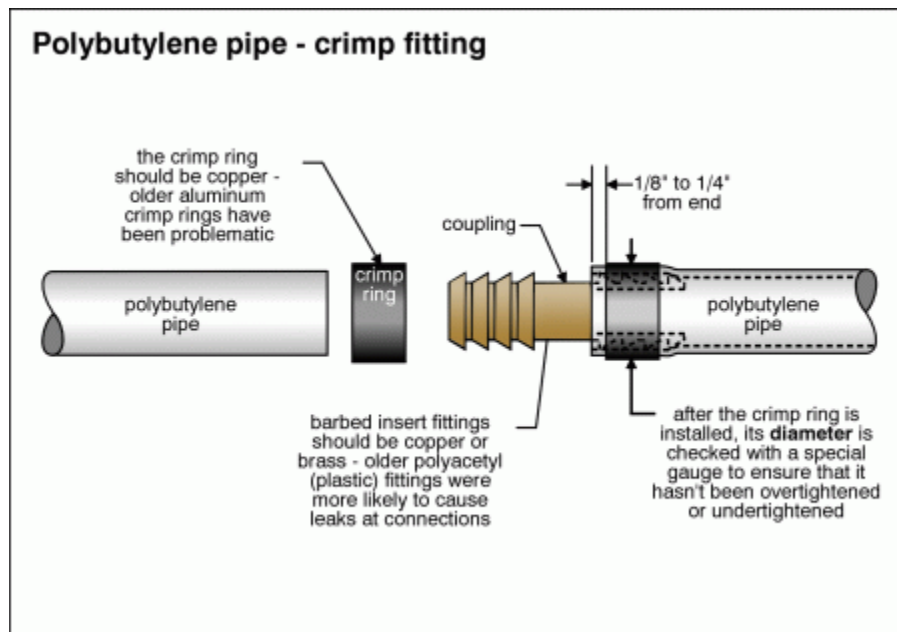
Condition: • [Suspect connections on polybutylene](#)

This house has Polybutylene Connections. These have been known to fail. Good practice is to inspect them on a regular basis to look for any leaks.

Implication(s): Chance of water damage to contents, finishes and/or structure | Leakage

Task: Monitor

Time: Ongoing

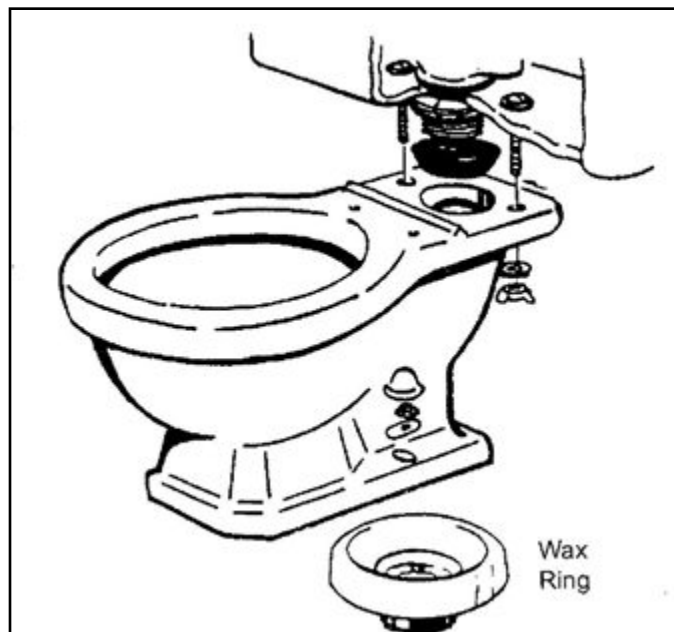
Condition: • The most common place for a Toilet to leak waste water is the Bee's Wax Seal. It is recommended that the seal be replaced every few years.

Implication(s): Water Damage to Floor Coverings, Sub floor and Ceiling below.

Task: Replace

Time: Discretionary

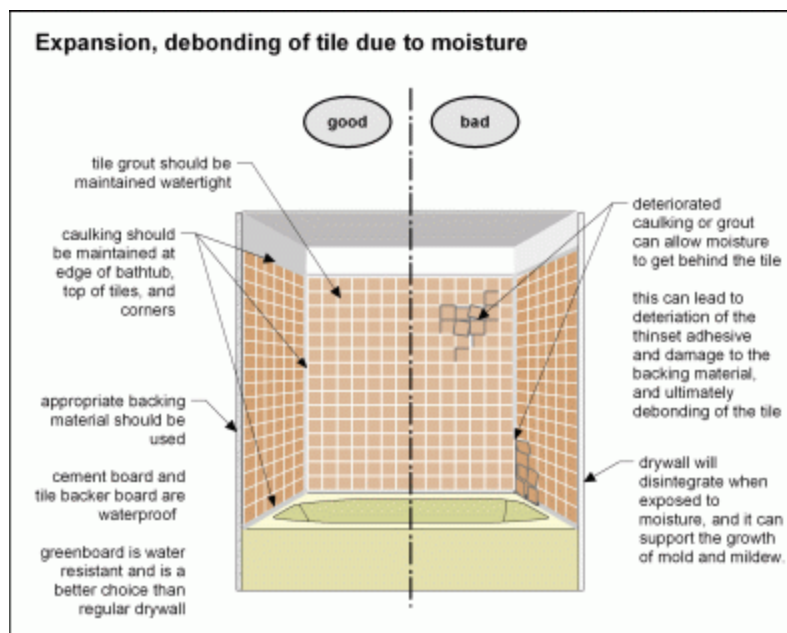
Condition: • [Caulking loose, missing or deteriorated](#)

Implication(s): Chance of water damage to contents, finishes and/or structure

Task: Repair or replace

Time: Immediate

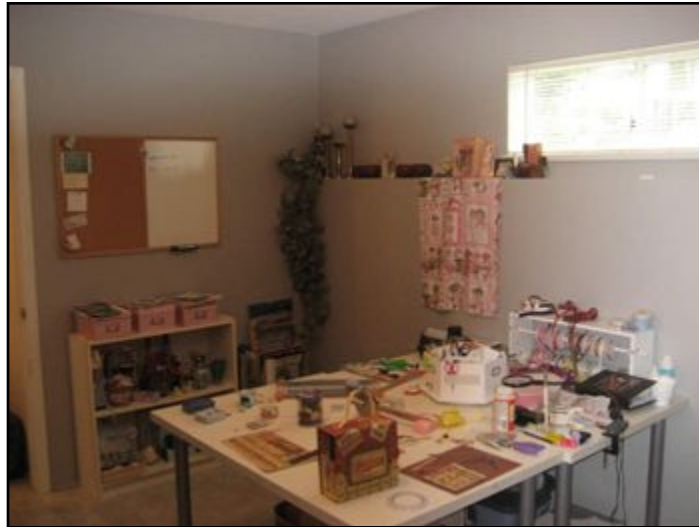
Condition: • Where Basement windows are more than 59 inches above the floor built in furniture is recommended to help with egress.

Task: Improve

Time: Discretionary

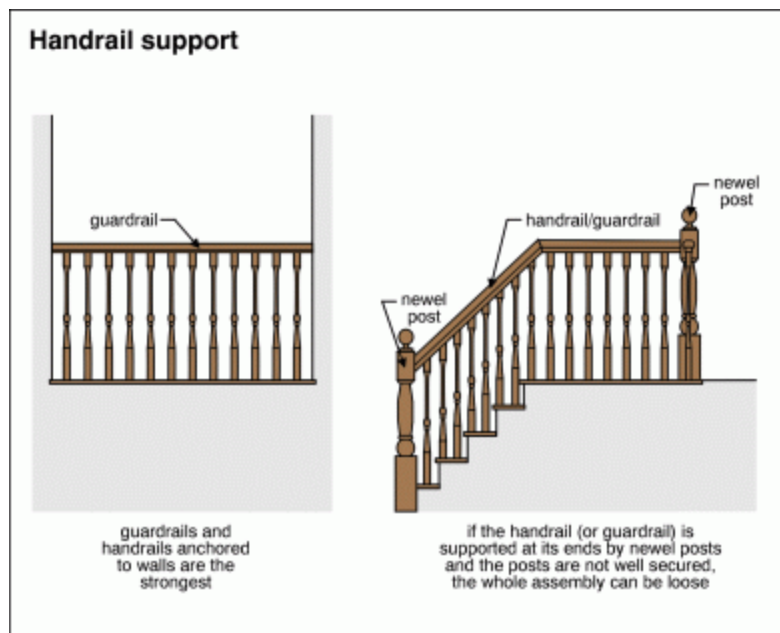
Condition: • [Loose](#)

The guardrails around the stairs are loose.

Implication(s): Fall hazard

Task: Repair or replace

Time: Immediate
