Your Inspection Report

123 Main Street
Coquitlam, BC V1V 1A1

INSPECTION DATE:
Monday, May 30, 2011

RE: Report No. 1010, v.0
123 Main Street
Coquitlam, BC
V1V 1A1

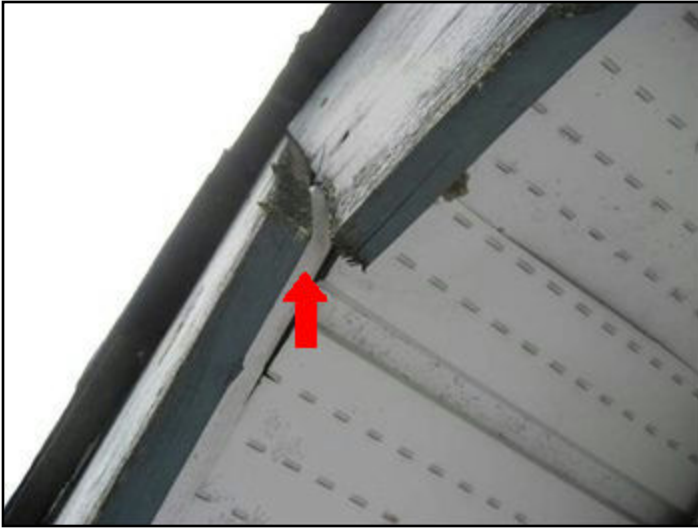
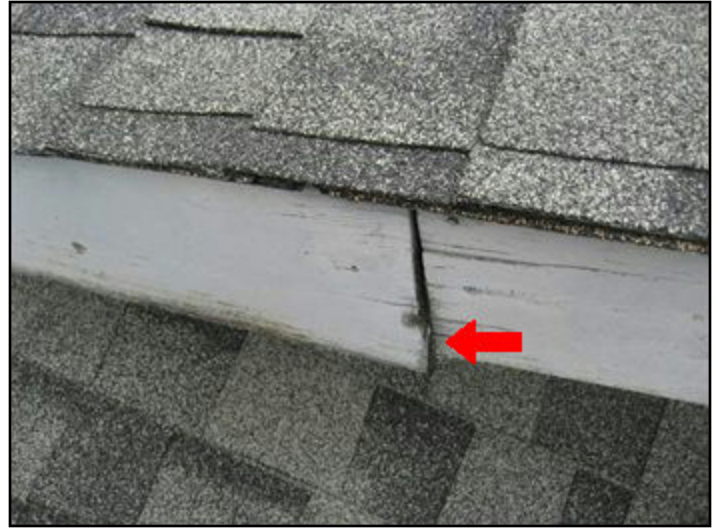
Condition: • [Loose or missing pieces](#)

The soffit is loose in many areas.

Implication(s): Cosmetic defects | Chance of water damage to contents, finishes and/or structure | Chance of pests entering house

Task: Repair or replace

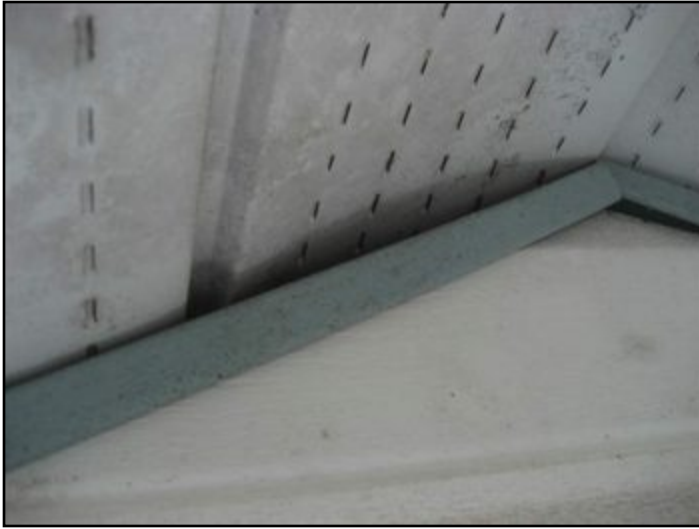
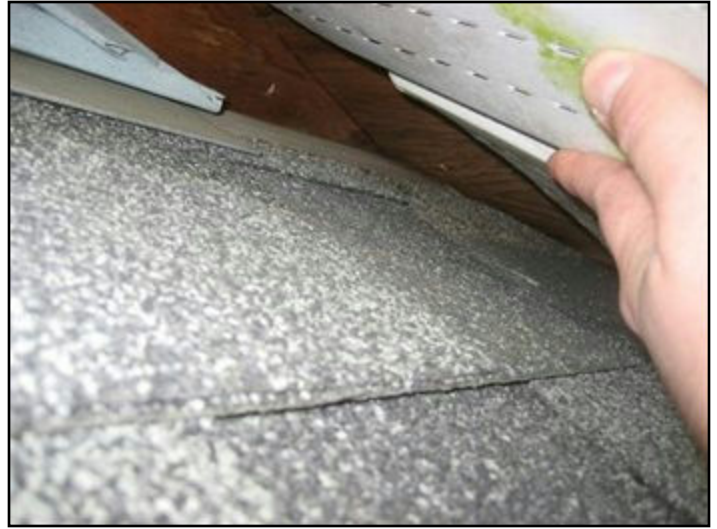
Condition: • [Damage](#)

The soffit on the south side is damaged.

Implication(s): Cosmetic defects | Chance of water damage to contents, finishes and/or structure

Task: Repair or replace

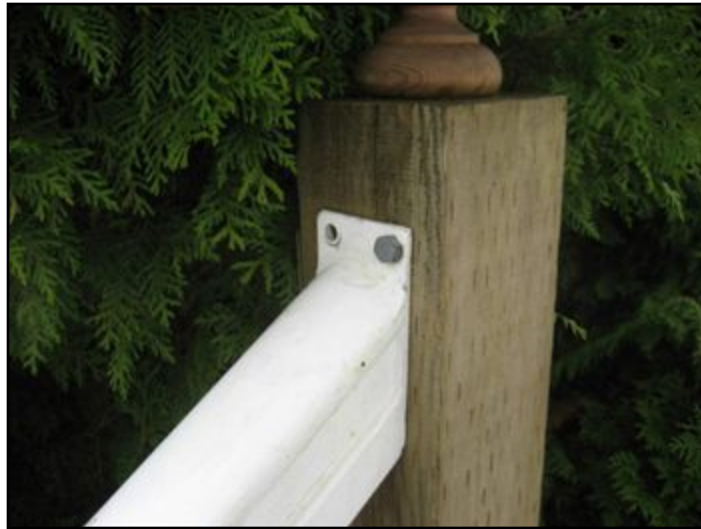
Condition: • [Spindles too far apart](#)

Stars from upper deck to lower deck have no spindles at all. This hand rail is also not very secure.
